The Role of Site Conditions on the Structural Damage in the City of Valdivia during the 22 May 1960 M_w 9.5 Megathrust Chile Earthquake

Abstract

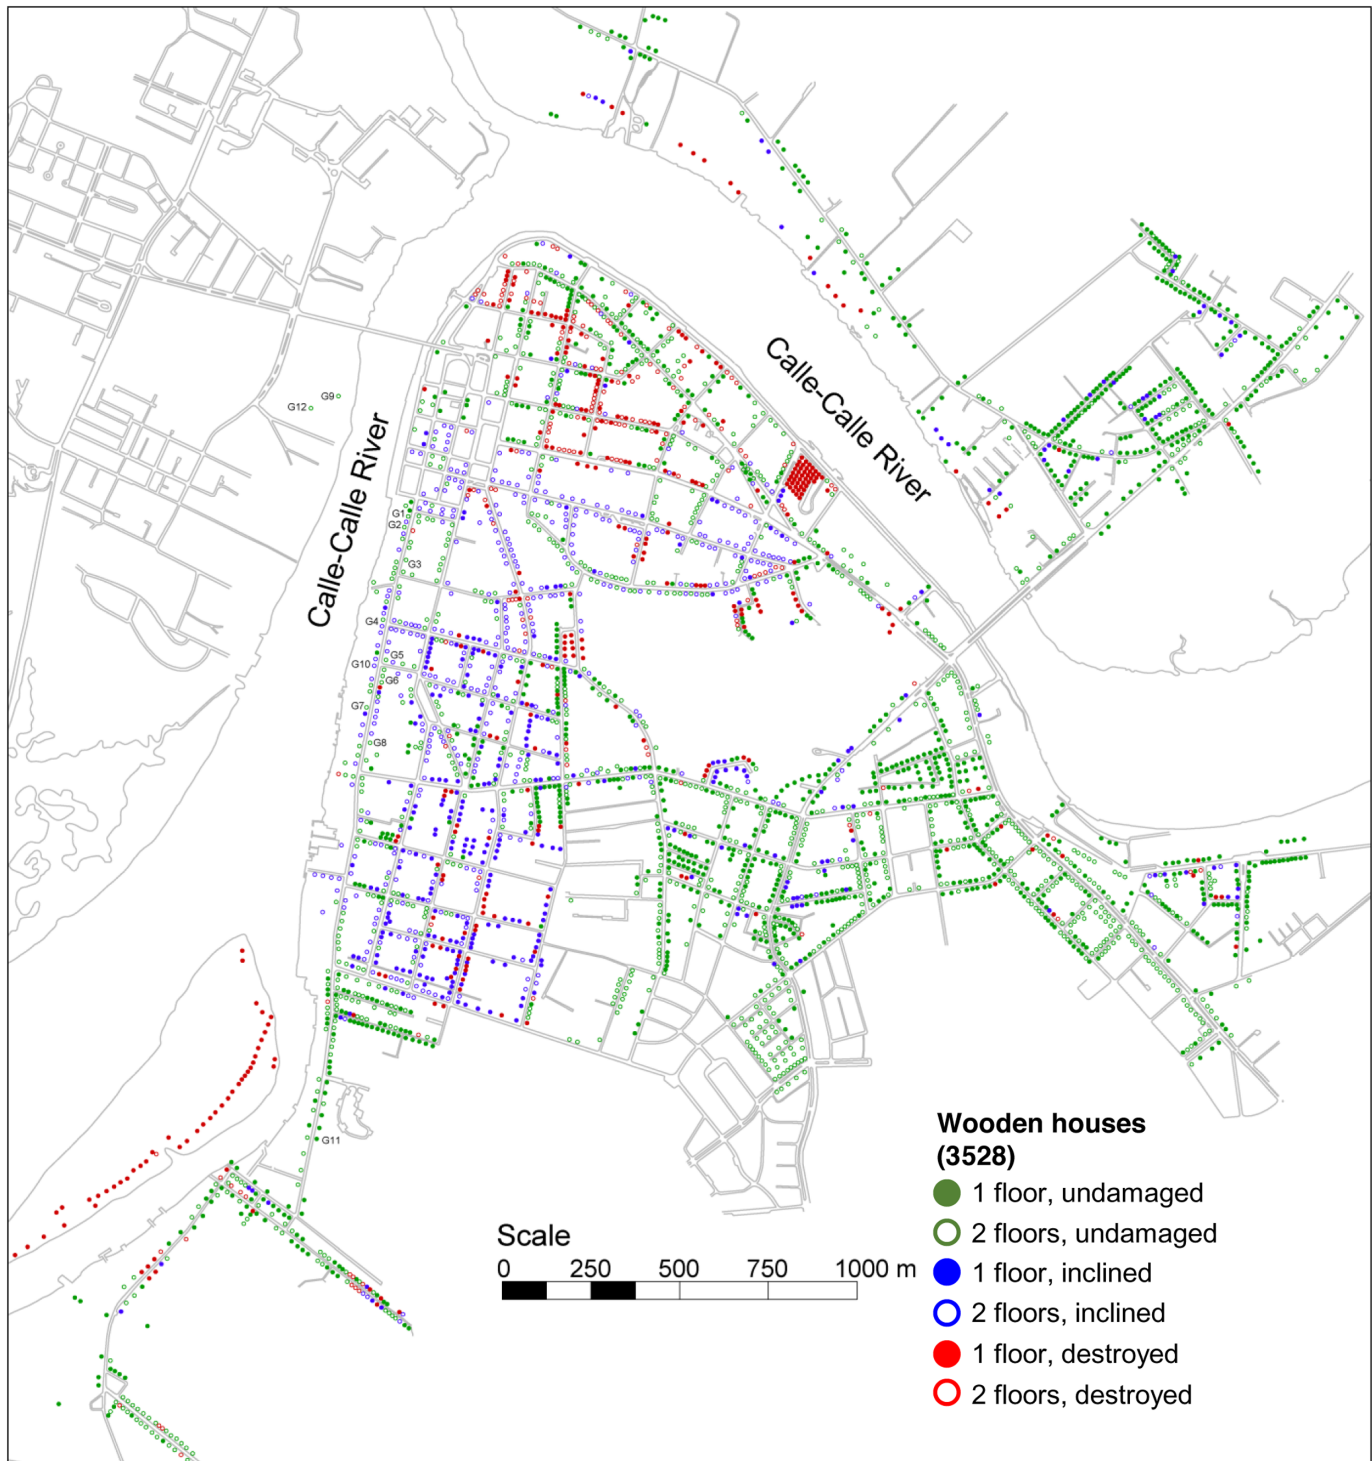
In general, wooden houses performed well during the earthquake. The failure of wood-frame structures was caused

Figure 5. Wooden houses undamaged, inclined, and damaged during the 22 May 1960 Chile earthquake (data from Weischet, 1963; Barozzi and Lemke, 1966; Lástrico, 1967). The location of the 12 undamaged German-style wooden houses are indicated as G1–G12. The color version of this figure is available only in the electronic edition.

by construction quality problems, such as insufficient nails and poor maintenance of the foundation system in the highly humid Valdivia climate. Wood-frame structures with lightly reinforced-concrete or unreinforced-masonry partitions or exterior walls behaved poorly. For instance, the unbraced reinforced-concrete firewalls on property lines between wooden buildings often fell, destroying or severely damaging the adjoining wood-frame houses (Steinbrugge and Flores, 1963).
